Case Study of Second Penang Bridge Ramp Collapse and Case Study of Hyatt Regency Kansas City Walkways Collapse

Nazifah Abdul Ghani, Nur Amanina Md Khir
Nur Hafiz Syazani Kamarudin, Nur Hafizah Saharum,
Nurhanis Mastura Mohd Haris Tan
Nur Syafiqah Rusli, Nur Farah Hanim Mohamad Kamal
School of Electrical Engineering
Universiti Teknologi Malaysia (UTM)
Skudai, Johor Bahru, Malaysia

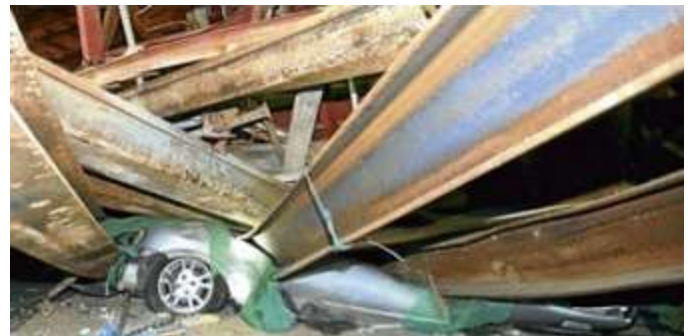
The incident caused the dead of one civilian and injured to others four which is two civilian and two workers which is from Indonesia and Myanmar. The list of the victims can be observed from Table 2. The victim that was killed in the incident was trapped in a crushed light green Kelisa. Figure 2 and Figure 3 shows the photo the light green Kelisa and the collapsed ramp respectively. In order to set free the victims, four hydraulic jacks are being installed to lift the debris and

Figure 2 Crushed victim's car

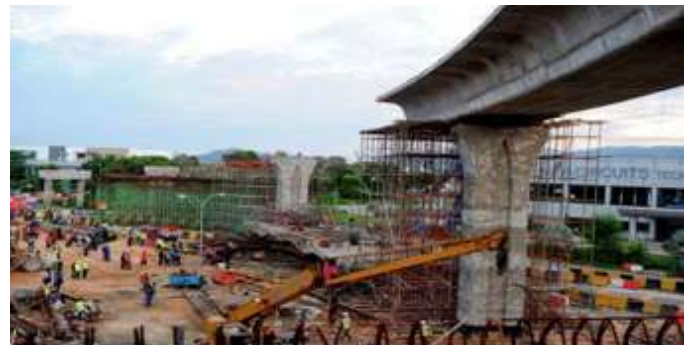
Figure 3 The collapsed ramp

Penang DOSH Director, Mohd Anuar Embi said that early investigations by his team found that failure of the formwork support was the cause of the collapse of the ramp. Before start a certain project, the designation of the project must have been approved by the responsible engineer. According to the act, contractor or workers needs to follow the exact design and any changes needs to be approved by the engineer or the designer. This is because, every parameter or calculation in the designation were designed to achieve the maximum quality of the project, then if the design was changed, it is could affect the quality of the project.

The last possible cause is the poor drainage system at the construction. Weather and soil condition factor is also another cause that has led to the incident. Land filling works have raised the height of the surrounding areas by about two to three meters. The land where the collapse occurred is still at its earlier level. This has created a water-retention pond of about one acre in size. The scaffolding was erected on ground that was dry. Rain had turned the low-lying ground into a water retention pond as there is no drainage to quickly remove rainwater from the area.

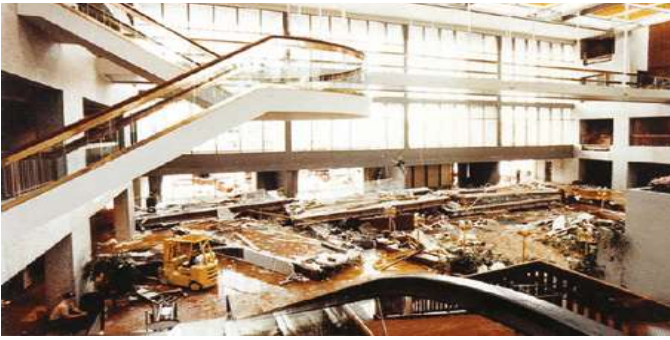
Figure 4 Situation at Hyatt regency Kansas City Walkways

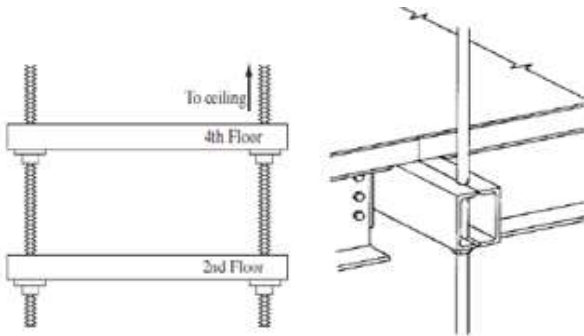
Figure 5 Original schematic drawing for second and fourth-floor walkways

This design required that the rods be threaded for most of their length in implementation process and this process increase the costs of the rods. Then, change in design is suggested by Havens to avoid requirement for threading long pieces of rod. Figure 6 shows new design after change is done to the original schematic drawing. The rods are not connected continuously from the ceiling to the fourth and second floor but only connected to fourth floor. Then, another rod is connected from fourth floor to the second floor.

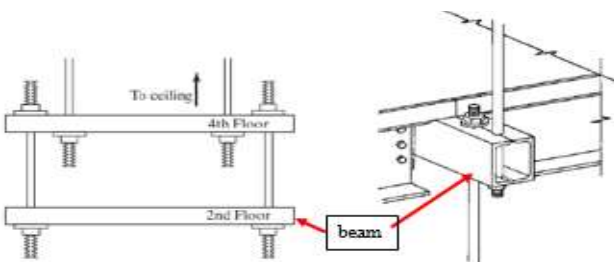
Figure 6 New schematic drawing for second and fourth-floor walkways

- In original design, beam for fourth and second floor is independently hung their weight to the ceiling. But, in the new design, beam at second floor is dependent on the fourth floor. This make the beam at second floor need to support weight from both fourth floor and second floor.

- With this new design, even before people entering walkways, the beam at fourth floor already support weight of the second floor. Added with 2,000 people entering walkways for both floor when the incident happens, weight that the beam need to support is doubled and become overload causes the beam cannot support the walkways anymore and collapse of both walkways happen.
- ### 2) Negligence of person in charge (Engineer) who gives approval for the design of the walkways.
- Subcontractor for fabrication and erection of the atrium steel, Haven Steel Company suggested the design to be change to reduce the cost of the rods. It is uncommon for the subcontractor to suggest change in structure, especially if the changes can lead to cost savings or easier fabrication.

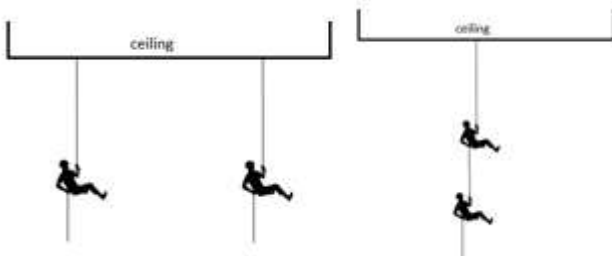
- Analogy that can be used to understand this design is when two people is hanging on the rope for support and grip. The first design is when two people hanging on the rope independently and the second design is when one people is hanging on the rope and the other one is hanging on the leg of the people hanging on the rope. Figure 7 shows the analogy. When one people is depending on other people to stay hanging on the rope makes the weight that the ceiling need to support increase and the grip that the first person is not strong.

Figure 7 Analogy of the design

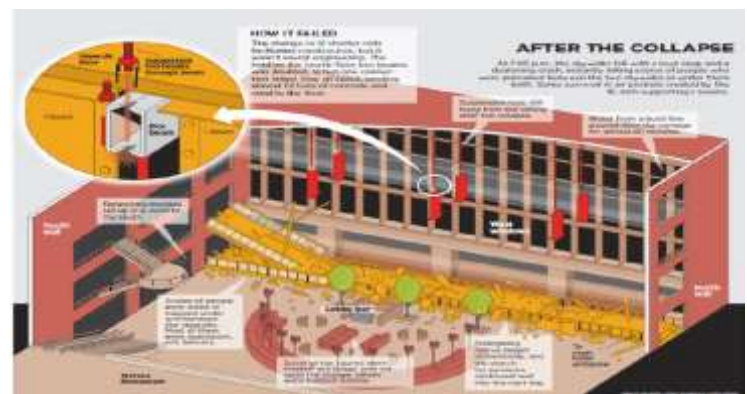
Figure 8 Situation after the collapse
