# Stadium Sultan Mizan Zainal Abidin's Roof Collapse and Teton Dam Failure Case Study

**Index Terms**—Stadium Sultan Mizan Zainal Abidin; roof collapse; Teton Dam; failed; design

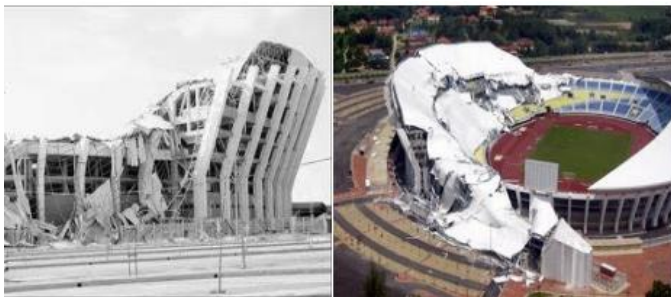
On 2<sup>nd</sup> June 2009, an undesired event occur which involve the roof of the stadium collapsed. Almost 60 percent of roof collapsed on the east wing of the stadium. Even though no one was injured during the incident, total damage estimated around RM250 million. On 9.00 am, based on the morning worker where they are doing some cleaning and maintenance, a huge crashing sound was heard. The support of the roof outside of the stadium had failed. Luckily, no worker was under the roof when its collapse. However, a vehicle outside the stadium were damaged by debris.

Figure 1: Stadium Sultan Mizan Abdidin collapse

Based on the journal report written by Fahad Ali Gul and Chauhdry Mehr Ali, the incident occurs due to the design error. It was reported that the design was inadequate and insufficient safety measure was used. In addition, the skill of the construction worker hired were inadequate as the design structure is complex. Defective welding was found in steel compound indicates poor workmanships.

Besides that, there is not enough support used to handle the weight of the roof itself. Huge gap was made which 30 meters wide between last concrete stump and the concrete buttress. In addition to that, buckling happen to the inclined pole shows that the load exceeds the buckling capacity.

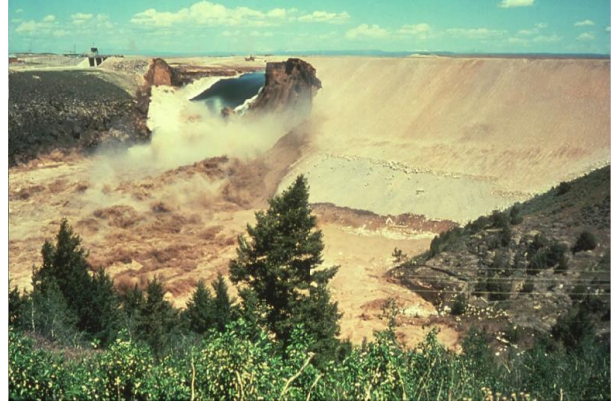
In 5 June 1976 (9.30 -10 am), presence of wet spot appeared on the downstream face (15-20 ft from right abutment). Then, the spot became flowing seepage & started washing out the embankment material. At 11am, dozers were sent in an unsuccessful attempt to fill the resulting eroded area nearby

the dam. Then, two bulldozers slid resulting banks collapse. Finally, the crest of the dam collapse and fall in the water.

*Figure 2: Teton Dam's failure*

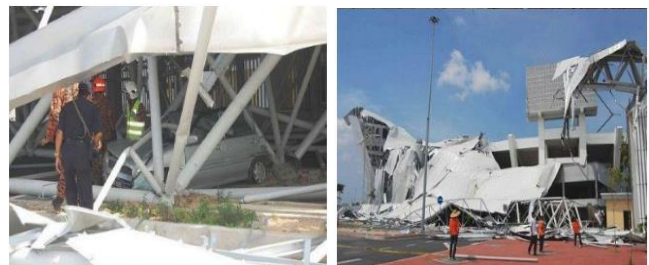
*Figure 4: Damages in SMZA collapse*

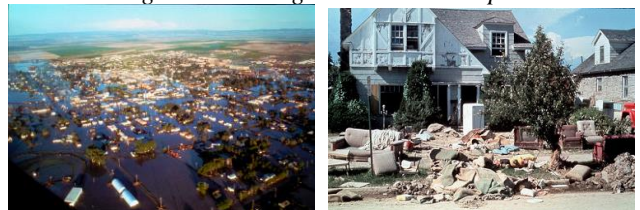
*Figure 5: Damages in Teton Dam's failure causes flood to few towns*
