A Case Study of Engineering Ethics on Sultan Mizan Zainal Abidin Stadium Roof Collapse and Teton Dam Failure

Index Terms—Stadium Sultan Mizan Zainal Abidin; roof collapse; Teton Dam; failed; design.

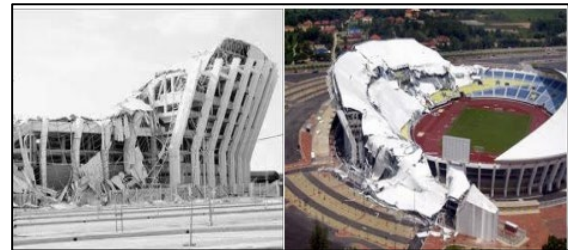
Figure 1: SMZA stadium collapse

On 2nd June 2009, an undesired event occur which involve the roof of the stadium collapsed. Almost 60 percent of roof collapsed on the east wing of the stadium. Even though no one was injured during the incident, total damage estimated around RM250 million. On 9.00 am, based on the morning worker where they are doing some cleaning and maintenance, a huge crashing sound was heard. The support of the roof outside of the stadium had failed. Luckily, no worker was under the roof when its collapse. However, a vehicle outside the stadium were damaged by debris.

Based on the journal report written by Fahad Ali Gul and Chauhdry Mehr Ali, the incident occurs due to the design error. It was reported that the design was inadequate and insufficient safety measure was used. In addition, the skill of the construction worker hired were inadequate as the design structure is complex. Defective welding was found in steel compound indicates poor workmanships.

Besides that, there is not enough support used to handle the weight of the roof itself. Huge gap was made which 30 meters wide between last concrete stump and the concrete buttress. In addition to that, buckling happen to the inclined pole shows that the load exceeds the buckling capacity.

Other factor that cause the incident is the condition where the strength of the material used must achieve the design requirement did not pass the preliminary test which cause the mechanical strength of the structure reduce. Poor project management also contribute to this incident because of the lack quality control and safety measurement. Also, SUKMA will be held in that stadium causing them fast pace the schedule to finish on time making them do the work while neglecting the quality control and safety measurement.

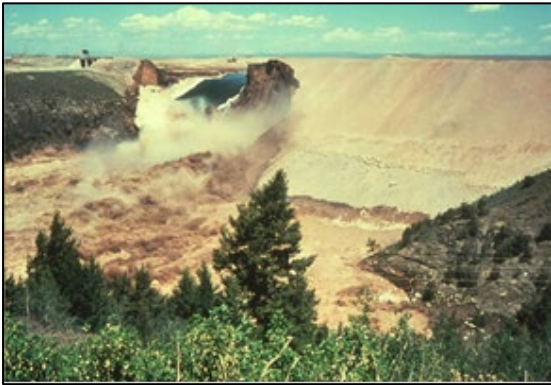
Figure 2: Teton dam failure

In 3 June 1976, there was 2 small seeps observed at the downstream. These 2 small seeps resulting released clear seepage with less than ¼ cfs. In 5 June 1976 (7.30am-8am), muddy water flowing from the rock in the right abutment about 15 ft above stream bed. Water flow rate about 20-30 cfs. This scenario noticed by project supervisors during that time. 5 June 1976 (9.00am), water flow rate had increase with 40-50 cfs. Besides that, other leaks

In 5 June 1976 (9.30am-10 am), presence of wet spot appeared on the downstream face (15-20 ft from right abutment). Then, the spot became flowing seepage & started washing out the embankment material. At 11am, dozers were sent in an unsuccessful attempt to fill the resulting eroded area nearby the dam. Then, two bulldozers slid resulting banks collapse. Finally, the crest of the dam collapse and fall in the water.

1. Too much reliance on the grout curtain

2. Inadequate quality of trench fill and silt used in the core.

3. Inadequate provision made for handling leakage.

4. Trenches in the canyon walls narrow & steep

5. Inadequate instrumentation to monitor conditions in the dam's embankment & surrounding canyon walls.

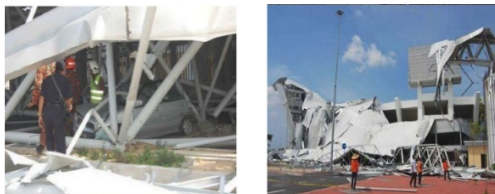
Figure 4: Damages due to SMZA collapse

The effects and damages for both cases has caused a large impact to some parties. It was not only affected in terms of money, but lives of several members too.
